Hydraulic Works

Project Background

The Tamarind Village is a luxury apartment commune situated along the banks of Tudor Creek in Mombasa, Kenya. It is located directly adjacent to the famous Tamarind Restaurant opposite The Old Town. In September 2017, severe storm weather caused a catastrophic failure of the sea wall, resulting in its collapse in

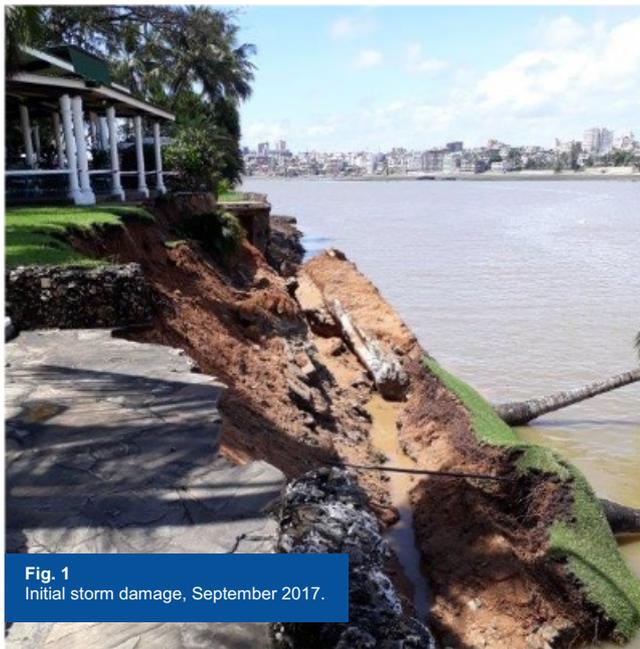
Fig. 1
Initial storm damage, September 2017.

front of the harbour restaurant. Extreme rainfall rapidly caused peak stormwater discharges and water run-off was only made worse by the ground that had already been saturated by rain in the weeks before. The 40m collapsed embankment had a blocked stormwater drain buried beneath the surface. Hydraulic pressure built up behind the existing concrete wall, finally exceeding its ability to retain the pressure. The existing foundations of the restaurant were left exposed leaving part of the building on a cantilever and at great risk of further structural damage. Emergency works were undertaken to temporarily protect the eroded embankment while the stakeholders sought for a permanent solution to restore and reinforce the banks.

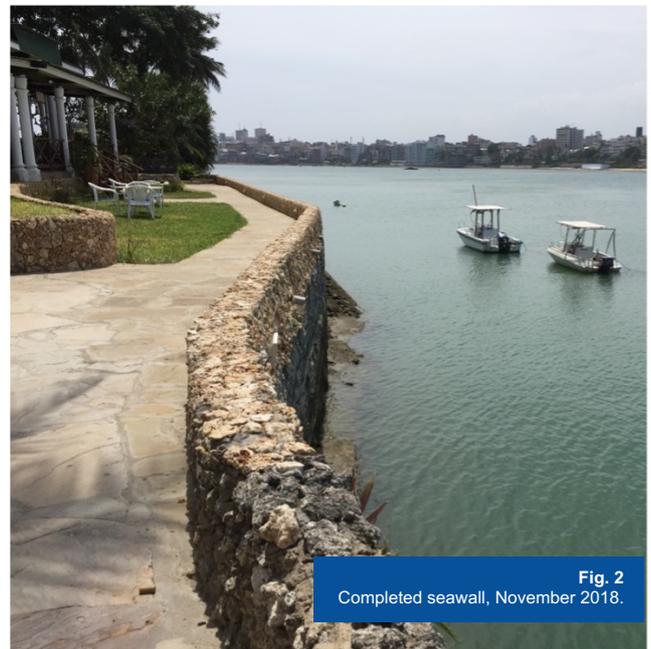
Fig. 2
Completed seawall, November 2018.

The solution implemented consisted of a robust, economic and free-draining structure with a vertical height of 4m. A Secugrid earth reinforced retaining structure using the ‘wrap’ system

with polymer coated gabion armoured facing was employed. The Secugrid ‘wrap’ system allowed the retaining wall to be reconstructed at 90degree; a vertical wall to rehabilitate the maximum plot frontage lost to erosion. The secugrid wraps were lined with a nonwoven geotextile; GeoMatt TB16, to prevent migration and wash out of fine soil particles under

hydraulic action. A heavy robust geotextile, NP120 was used in the foundation and toe of the structure to withstand the coarse coral reef base 2m below the water level, to provide a stable, level base and to limit undermining by the creek tidal current. The gabion facing element provides high performance hydraulic erosion protection and UV protection for the Secugrid reinforced retaining wall. The 2x1x1m gabions used in the facing element are made from high quality steel wire which is heavily galvanized to provide long term corrosion protection. An additional polymer coating was applied to give superior protection in more aggressive marine environments and give a longer design life.

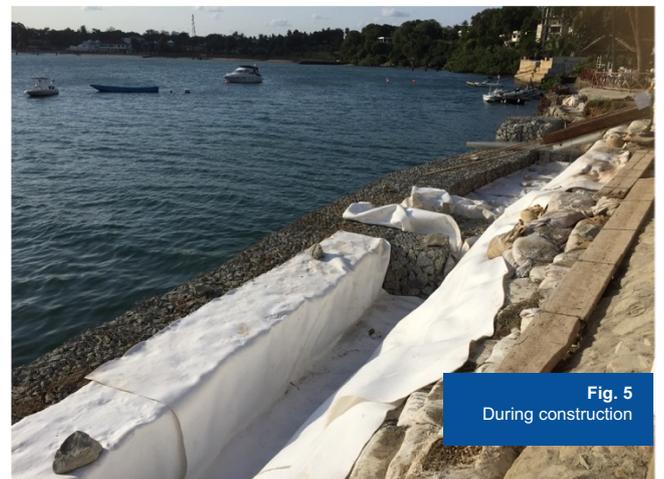
The weak parameters of the existing soil, together with the potential further erosion of the collapsed embankment with each high tide, required urgent reinforcement. Secugrid 30/30Q6 was selected as the primary reinforcement material. It provided a quick and relatively low-cost solution in terms of

ease and speed of construction as well as a low ecological impact in the coastal environment.

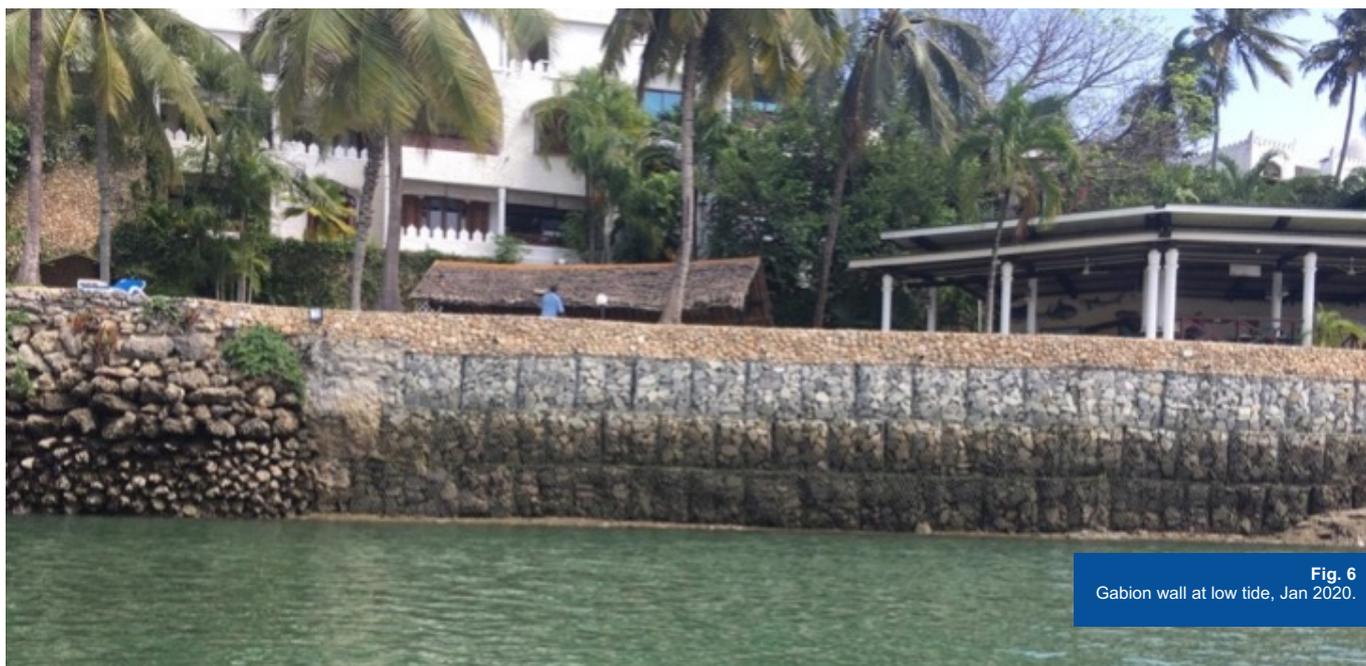
Fig. 6
Gabion wall at low tide, Jan 2020.

The works were executed by Bulkon Builders as the main contractor. The results were excellent and the rehabilitated embankment performs just as expected. The Secugrid ‘wrap’ system with a gabion facing proved to be the right solution, as it took into consideration the various site constraints as well as issues of constructability, design life and economics, all of which played a major role in the final decisions.
